# Bridge Inspection Program

## FY 93 Routine Inspections

October 1993

New England Division

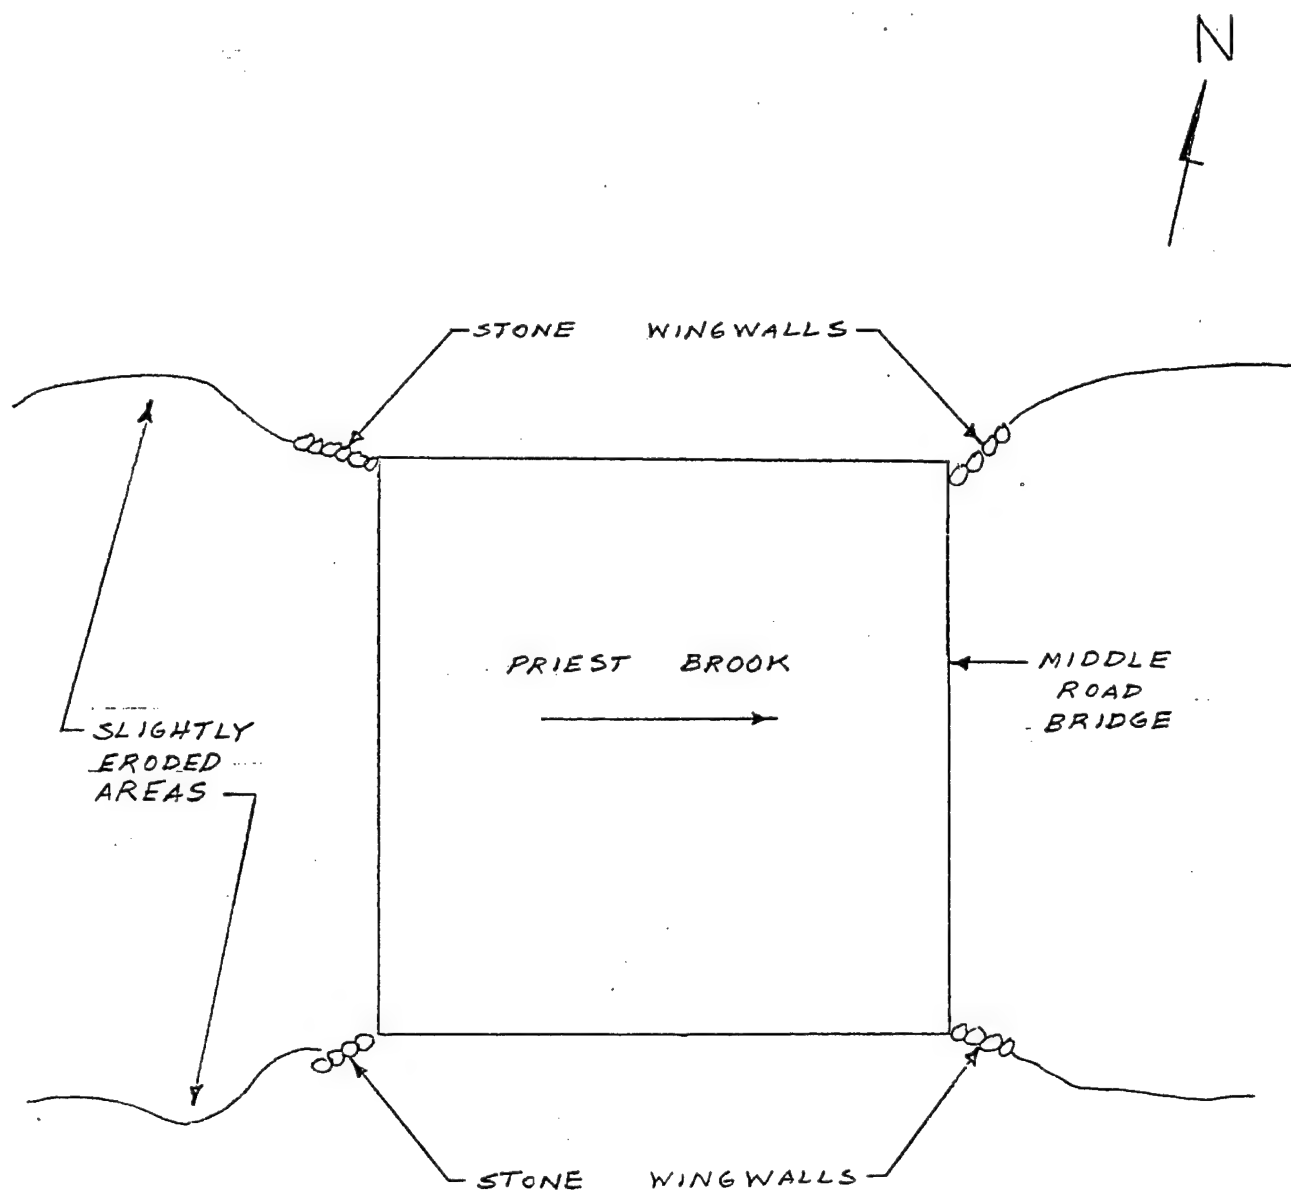
PLAN

DEPARTMENT OF THE ARMY NEW ENGLAND DIVISION CORPS OF ENGINEERS WALTHAM, MASS.	
DES. BY	PS
DR. BY	PS
CK. BY	
MIDDLE ROAD BRIDGE SKETCH BRIDGE SCOUR STUDY BIRCH HILL DAM RESERVOIR	
GEOTECH. ENG. BR.	SCALE: NTS
SK. NO. 3	DATE: 12 AUG. 93

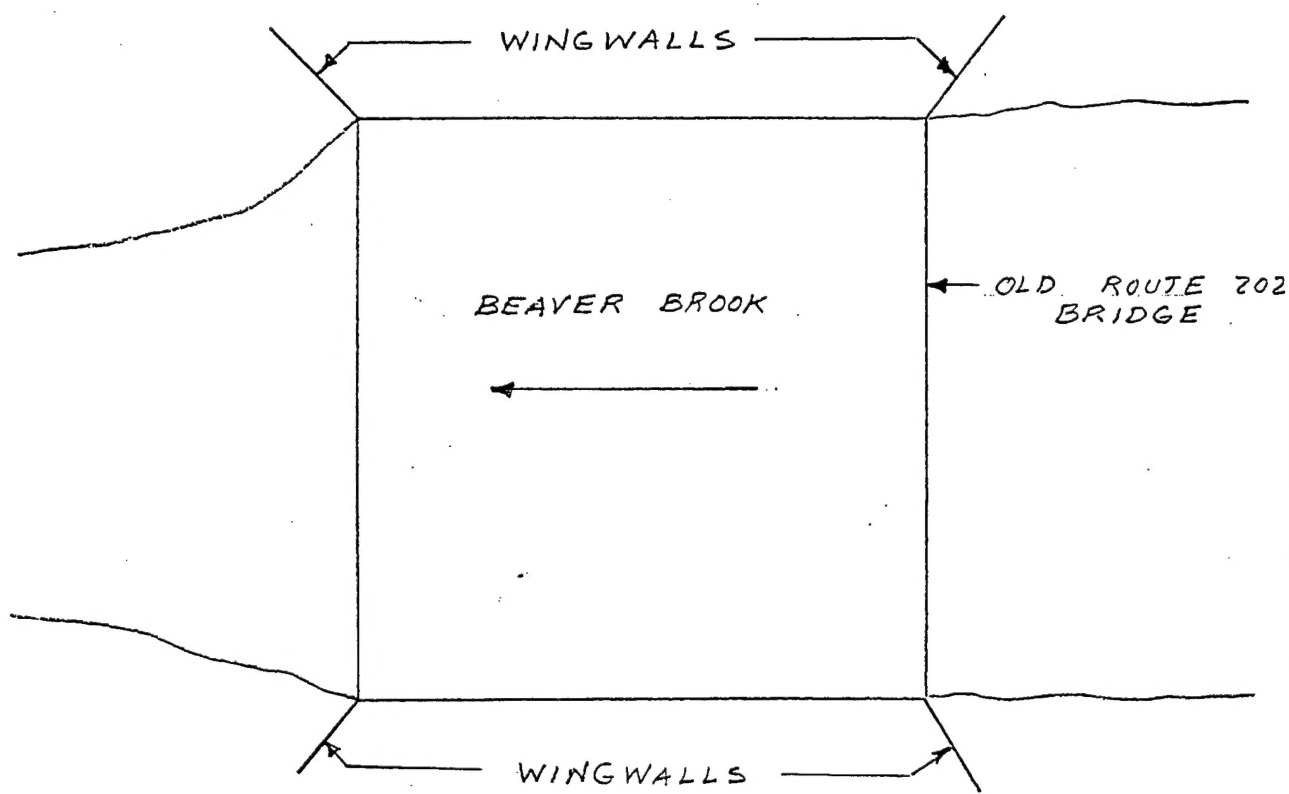
PLAN

DEPARTMENT OF THE ARMY NEW ENGLAND DIVISION CORPS OF ENGINEERS WALTHAM, MASS.	
DES. BY	PS
DR. BY	PS
CK. BY	
OLD ROUTE 202 BRIDGE SKETCH BRIDGE SCOUR STUDY BIRCH HILL DAM RESERVOIR	
GEOTECH. ENG. BR.	SCALE: NTS
SK. NO. 4	DATE: 12 AUG 93

Substantial scour problems were not observed near the Old Route 202 bridge. No remedial or maintenance measures are recommended now at the Old Route 202 bridge.
